Asset Management in the Water/Wastewater Industries:

A Case Study from the Upper Occoquan Service Authority (UOSA) in Centreville, VA

Mike Matichich
FTA State of Good Repair Roundtable
Chicago, Illinois
July 22, 2010

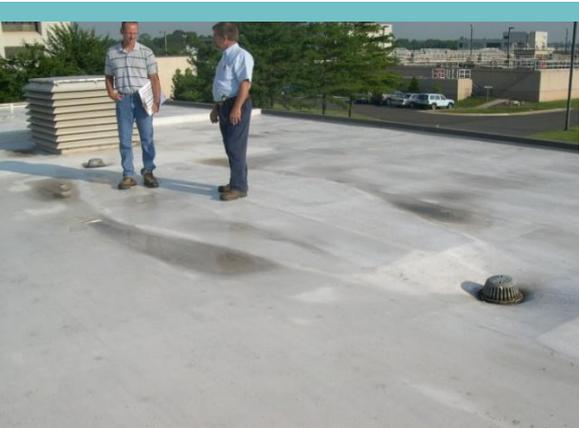
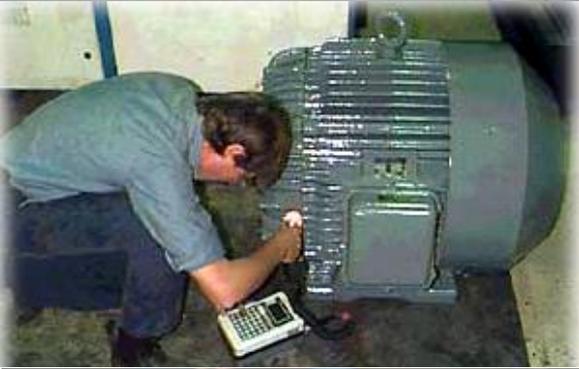
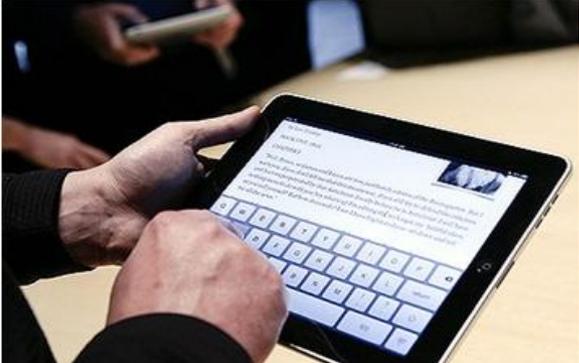
Condition assessments were conducted using a step-by-step process that can be sustained

1. Asset data and history were gathered
2. Assessment criteria were developed with UOSA for each type of asset
3. Information was uploaded to CH2M HILL's Asset Condition Evaluation System (ACES) tool
4. Field condition assessments were conducted
5. Risk results were calculated

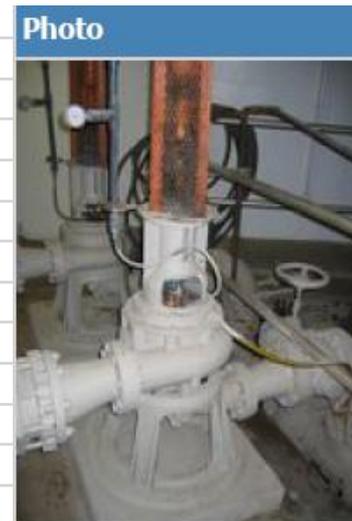
UOSA Asset Condition Assessment

This example illustrates specific questions by asset type and how answers were documented

Asset	160	Location	Digester Complex Buildings (C1)
Parent Number	0503030000	System	0503020402
Asset Description	PUMP CENT	Inspection Date	6/19/2008 12:00:00 AM
Comments	Picture 60

Question	Answer	NA	Flag	Answer Comment
Vibration Measurement	2 2 -Good .039 - .15 inches/sec			.1 in / sec
Mounting	2 Good			
All Safety Guards Present	1 yes			
Acceptable Noise	1 yes			
Absence of Pump Cavitations	1 yes			
Absence of Leaks	1 yes			
All Components	1 yes			
Lubrication OK at Inspection	1 yes			
No Mechanical Seal Leakage		X		
Operating at Inspection	1 yes			
Corrosion - Structural Metals	2 Slight staining/small chips			
Infrared	1 Negligible Ambient			
Packing Gland/Seals	2 Normal			
Pipe Alignment	1 Straight			
Belt/Direct Drive/Couplings	2 Minor Wear			
Gauges Operational		X		
Obsolescence	1 Currently supported

Condition Score

1.429

Condition Category

Very Good No corrective maintenance needed

- Three non-destructive tests were used for the condition assessments
 - Vibration (inches/sec) horizontal, vertical, and axial
 - Thermography
 - Oil analysis
- No invasive techniques were used
